Tech Bulletin #5
October 14, 2007

Inside Edge Wear on Dual Wheel Applications

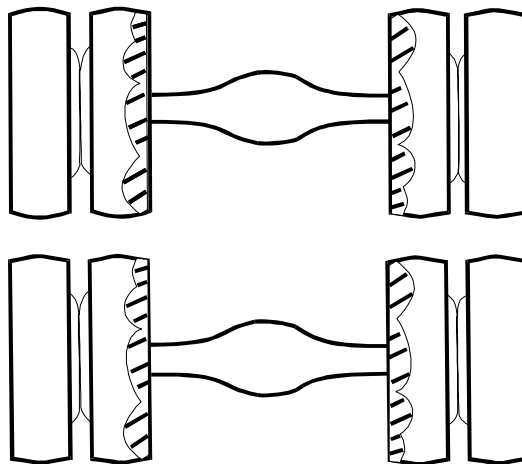
For ten years now I have advocated tightening wheel bearings to less than 5 thousands end play to reduce or eliminate inside cupping on trailer and drive tires.

But lately we have run into situations where cupping exists but the bearings are not loose. It appears there was a change in the industry while I was otherwise occupied.
